# South Branch Vermillion River: Minnesota Department of Natural Resources Geomorphic Overview

Ecological and Water Resources Division, Clean Water Team - Central Region

May 2020

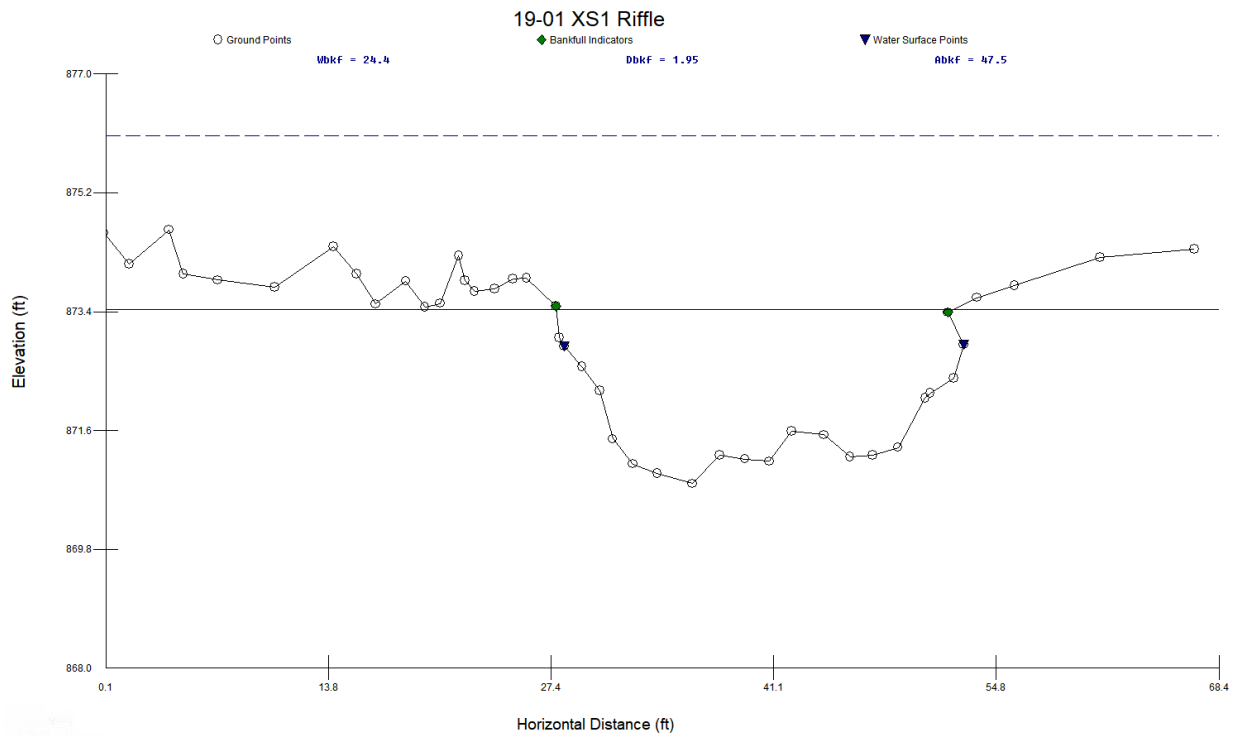
Lowering of the channel elevation, also known as incision, is a strong indicator of channel instability and accelerated rates of bank erosion. Incision is measured by bank height ratio (BHR), where the lowest bank height is divided by the maximum depth at bankfull (Figure 11). The average bank height ratio of the survey is 1.1, considered not incised. A measured entrenchment ratio of 16.41 shows that at flood flow levels the stream has access to a wide floodplain (Figure 12).

Figure 12. Cross section of riffle, showing bankfull (solid line) and flood-prone elevation (dashed line).

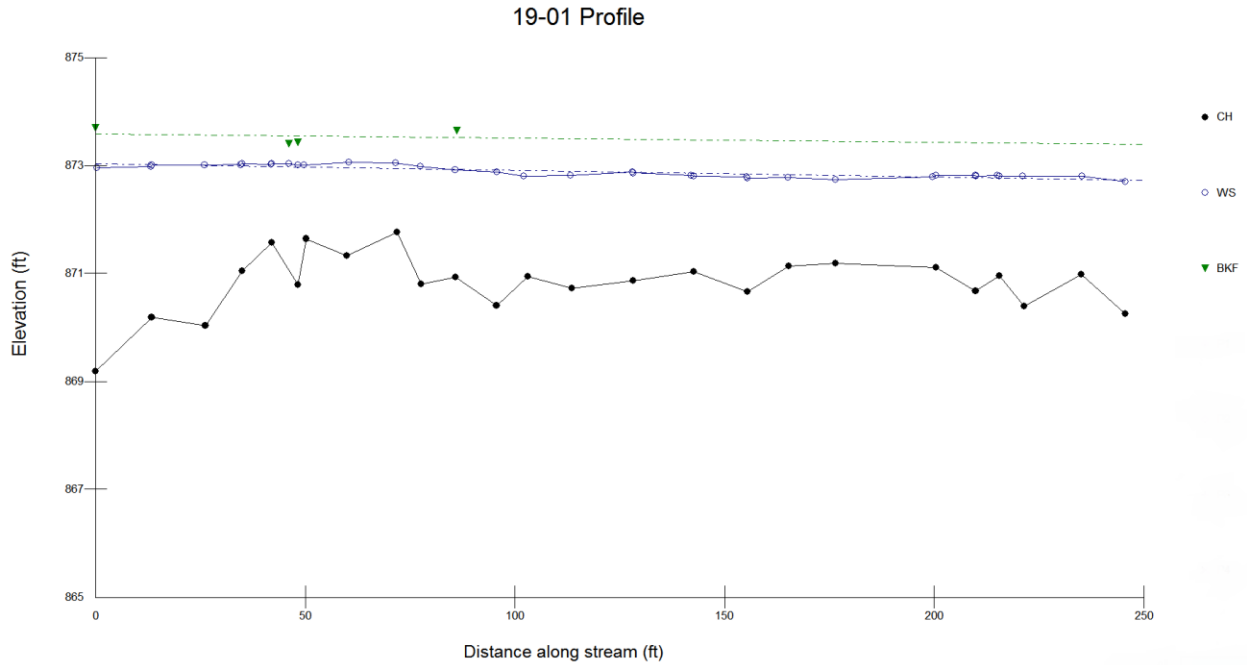
The longitudinal profile is 250 feet long with one representative riffle cross section. The profile shows little differentiation between riffles and pools, a characteristic of E stream types in this region (Figure 13). However the stream did have diverse scour pools associated with vegetation and overhanging woody material, fairly typical of low width to depth systems in this area.

Figure 13. Longitudinal profile of survey 19-01.

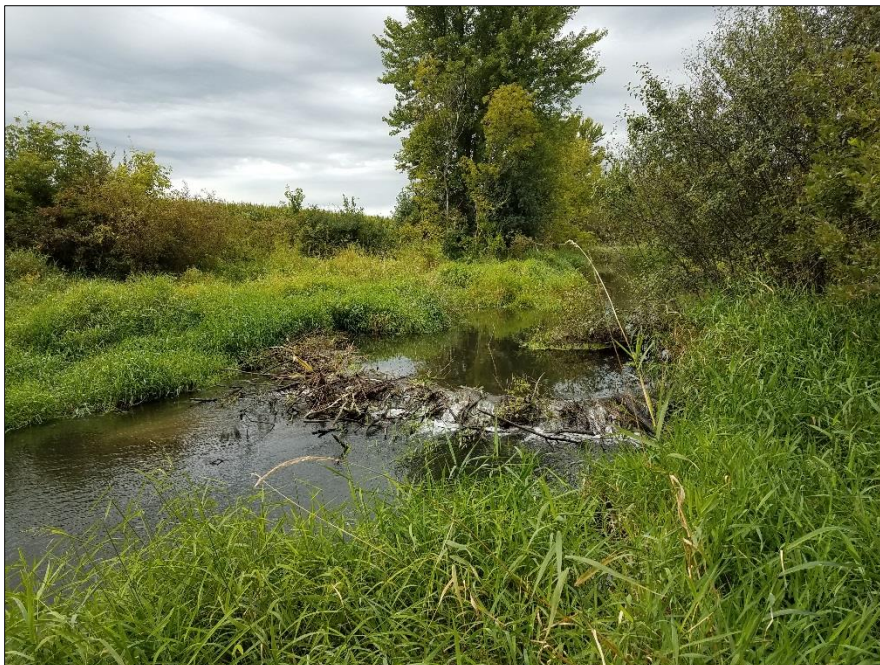
No bank erosion was observed in this reach. Low stream bank heights and dense vegetation help to stabilize the surveyed reach (Figure 14)

Figure 14. Photo of stream just upstream of profile of survey 19-01.

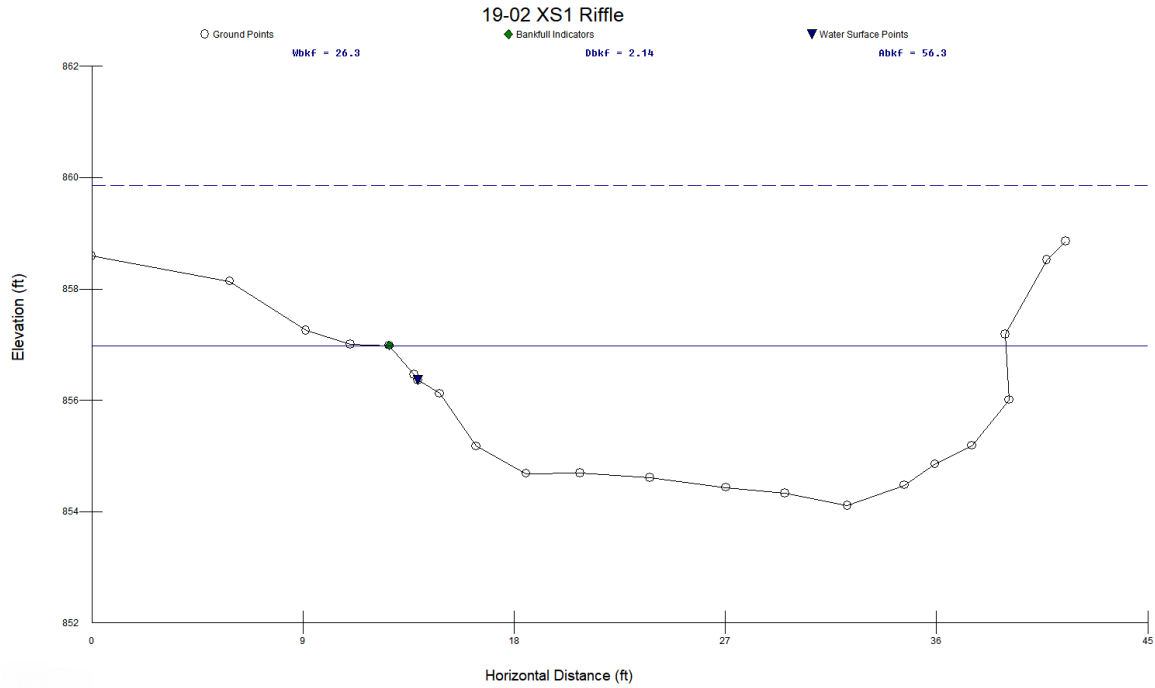
The average bank-height ratio for the survey is 1.0, considered stable. A measured entrenchment ratio of 5.49 shows the stream is connected to the floodplain during flood flows (Figure 16).

Figure 16. Cross section of riffle, showing bankfull (solid line) and flood-prone elevation (dashed line).

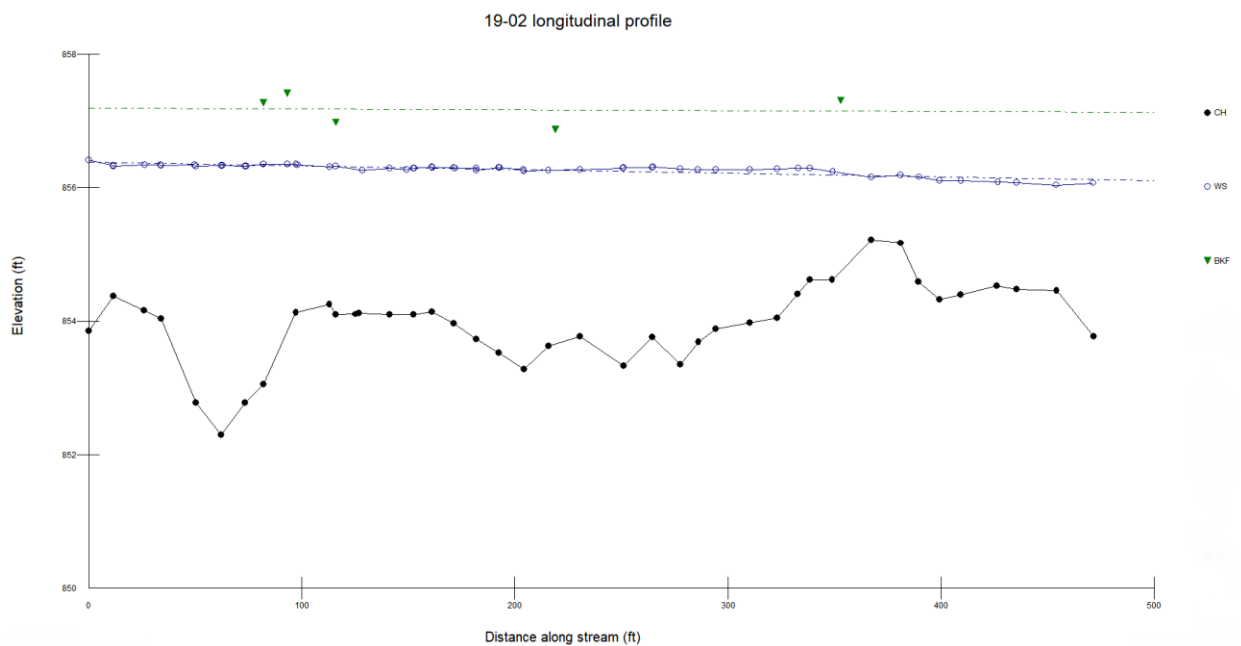
The longitudinal profile is 500 feet long with one representative riffle cross section. The profile shows three riffles and three pools within the surveyed reach (Figure 17). The shallow riffle at approximately 400 feet, is caused by a culvert outlet of unknown beginning. The pools are deep lateral scour pools associated with outside curves, unlike the pools caused by downed woody material in the upstream surveyed reach.

Figure 17. Longitudinal profile of survey 19-02.

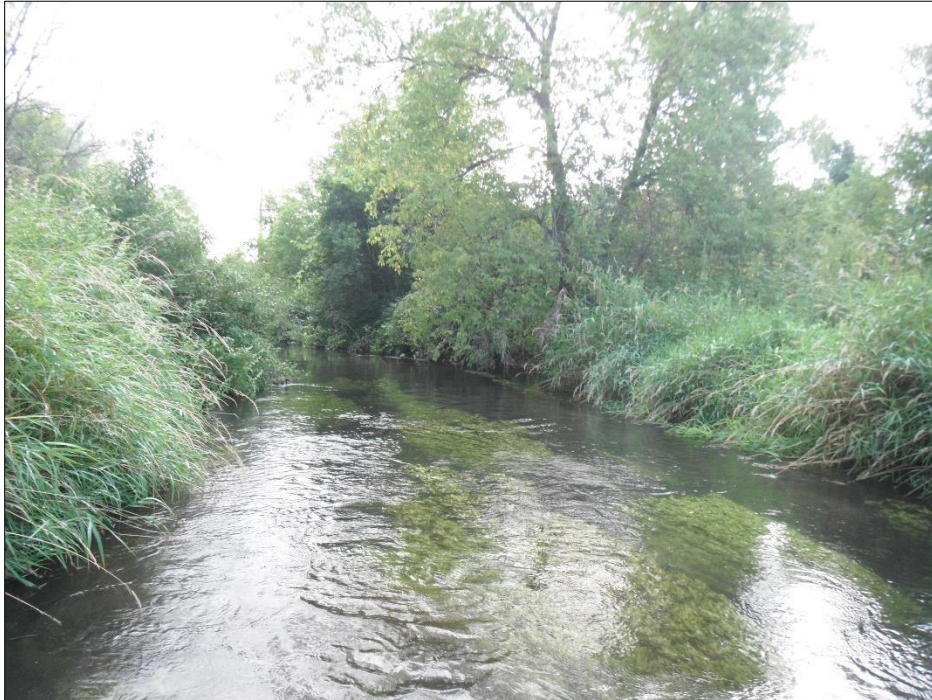
No measureable eroding banks were observed in this reach due to low stream banks and dense vegetation stabilizing the banks (Figure 17).

Figure 18. Photo of survey reach 19-02, showing dense vegetation along stream channel.

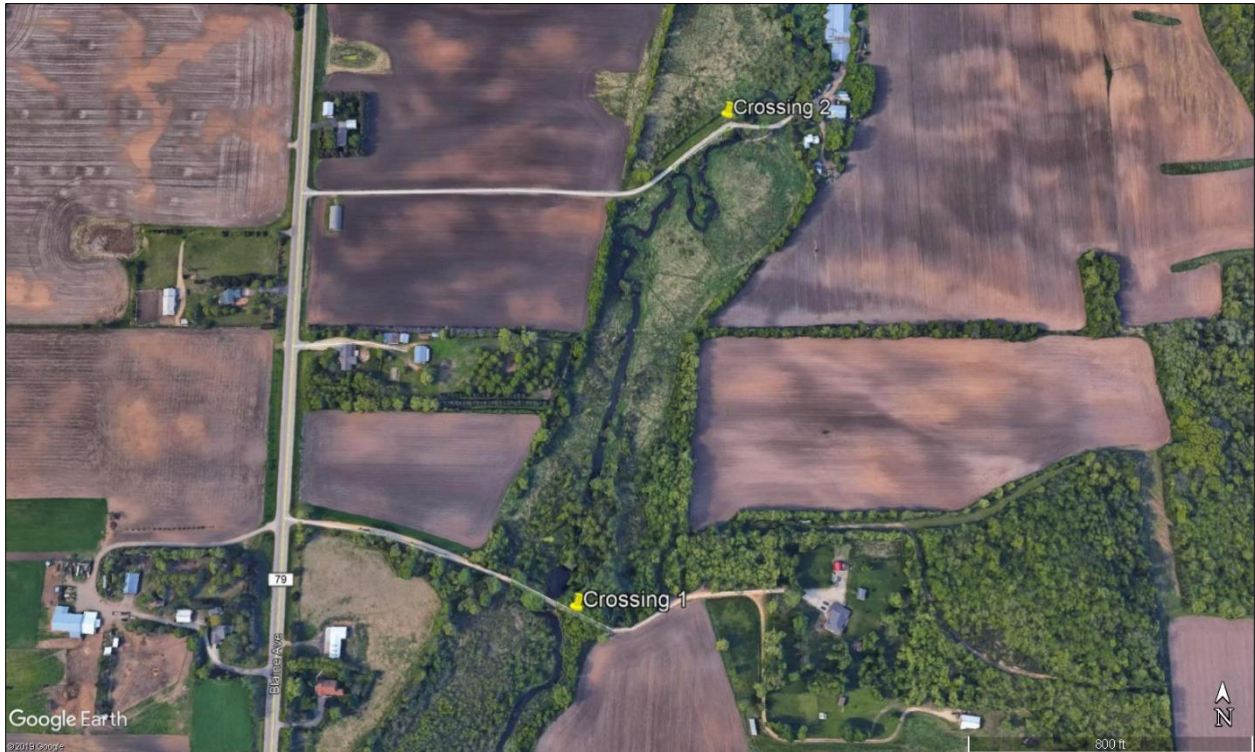
The DNR River Ecology Unit conducted a culvert assessment in this watershed. Two private crossings were identified as undersized on the main branch (Figure 19). Undersized culverts negatively affect channel stability causing water back up and reducing the channels ability to transport sediment, leading to upstream aggradation. The upstream aggradation flattens channel slope and increases lateral channel migration, resulting in streambank erosion. Downstream undersized culverts are scour pools, caused by an increase in exit velocity. One crossing (Crossing 1) has a total width of 14 feet and the other crossing (Crossing 2, was scheduled to be replaced in 2018, but it is unknown if it was replaced) has a width of 5 feet (Figure 18). Survey 19-01 was immediately upstream of these crossings and identified a bankfull width of roughly 25 feet. It is important to match bankfull width and area when designing culverts, discussed in further detail in Conclusions and Recommendations section.

Figure 19. Location of undersized private crossings along main branch of South Branch Vermillion River.

To reduce the negative impacts of previously identified crossings, they should be altered to match the pattern, shape, and profile of the adjacent upstream section of stream documented in Survey 19-01. According to the Minnesota Department of Transportation Report (MNDOT 2019), when designing culverts;

1. *Design the culvert slope to match stream channel slope*
2. *Place the culvert to best match stream alignment*
3. *Design the culvert opening to bankfull channel width or slightly greater*
4. *Provide culvert flow depth comparable to channel flow depth for aquatic organism passage (not over-wide and too shallow)*
5. *Provide a continuous sediment bed with roughness similar to the channel*
6. *Maintain continuity of sediment transport and debris passage, similar to adjoining reaches*
7. *Design for safety to the general public, longevity, and resilience*

In addition to the MNDOT recommendations, the (DNR 2014) provides best practices for design of structures impacting Public Waters. In addition, it is also important to match bankfull cross sectional area for the primary culvert. A design should also consider additional culverts to allow floodplain continuity through the road prism. Above and below the actual culvert or span bridge, grade control measures are beneficial in reducing the risk of head cuts, as well as protecting the infrastructure of the culvert.

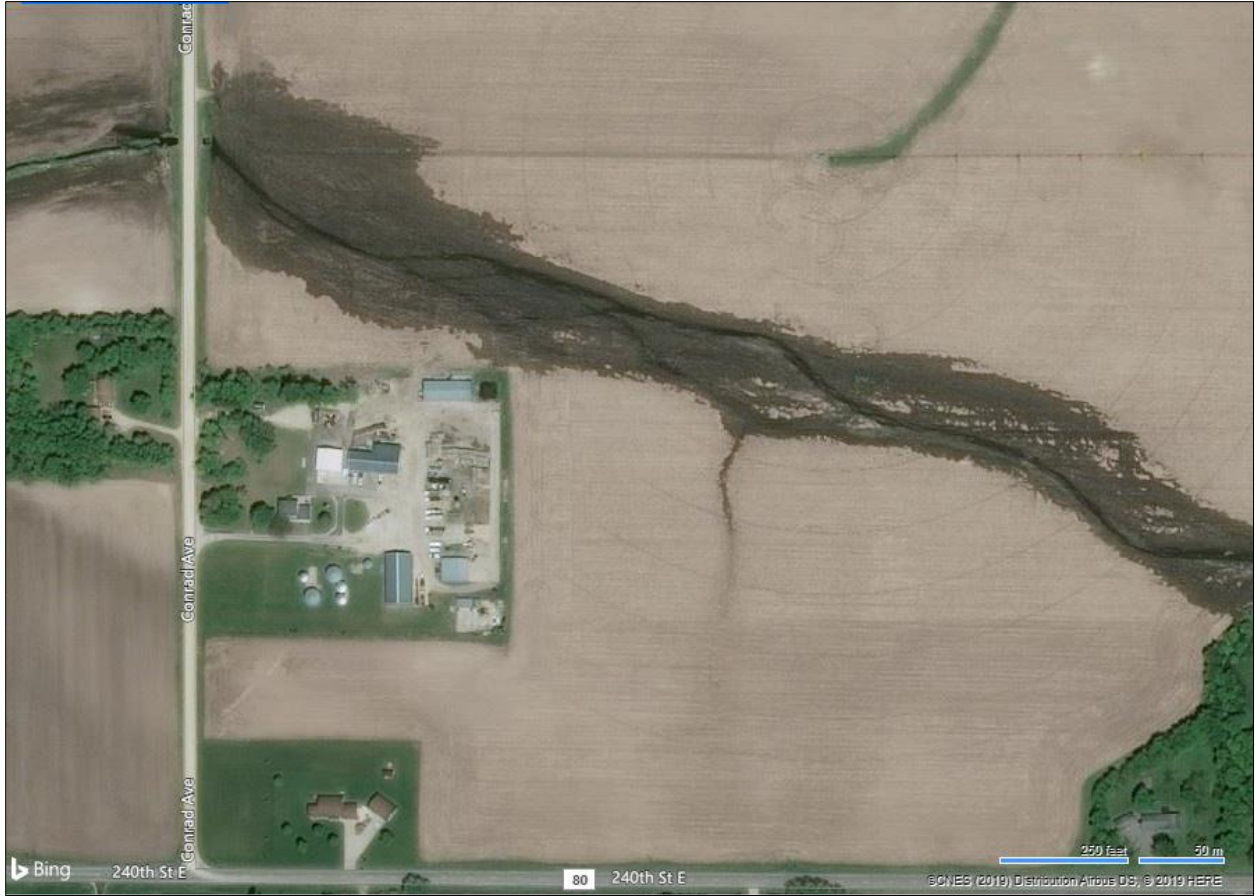
Although soil erosion susceptibility is low, there are areas of possible surface erosion that can be improved. Rill erosion, caused by concentrated water running through fields, is the most common form of surface erosion in the watershed. The erosion directly enters a drainage system, where the sediment could then be transported downstream. An aerial photo review identified signatures of surface erosion at locations within the watershed (Figure 19).

Figure 20. Example of rill erosion occurring on agricultural field.
