# South Branch Vermillion River: Minnesota Department of Natural Resources Geomorphic Overview

Ecological and Water Resources Division, Clean Water Team - Central Region

May 2020

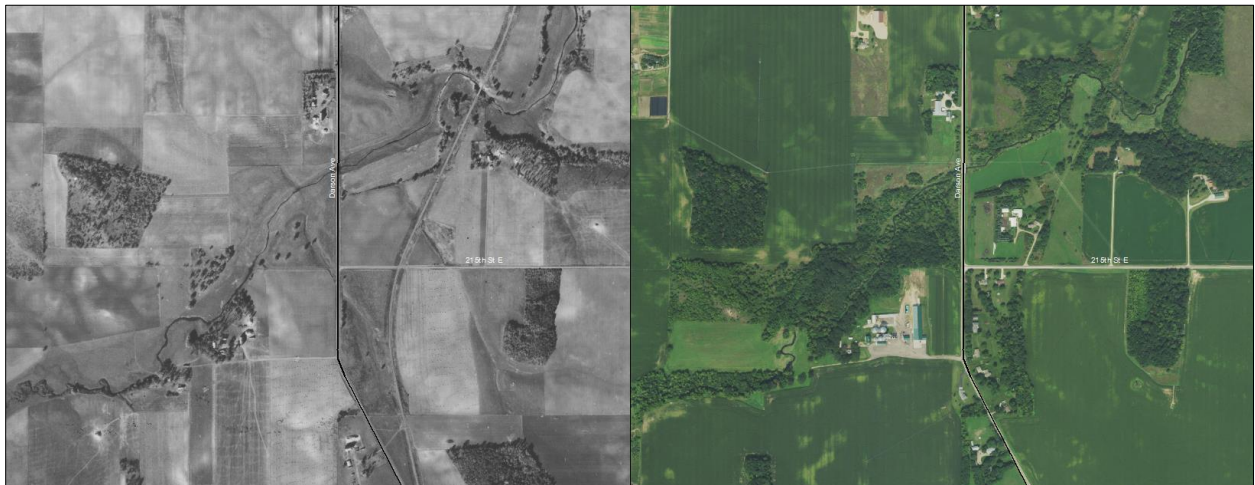
The quality of water is often a product of the historic and current land use of its watershed. Knowing past changes may lead to better understanding of the current conditions and potential sediment sources, as well as allow for more effective management planning. Prior to European settlement, prairie made up 75% percent of the land cover in the South Branch Vermillion watershed. The remaining land cover was oak openings (8%), aspen oak-lands (6%), open water (5%), and wet prairie (5%). Significant land use changes occurred shortly after European settlement as agricultural activities increased. Currently, according to the National Land Cover Dataset (2016), land use is dominated by cultivated crops (68%); followed by pasture/hay (14%), forested/grassland (10%), developed (5%), and wetland (3%). Although difficult to quantify, georeferenced historical aerial photos show a large improvement in riparian vegetation from crops to perennial plants, throughout the watershed since the turn of the century (Figure 2).

Figure 2. Comparison of riparian vegetation improvement from 1937 (left) to 2017 (right).

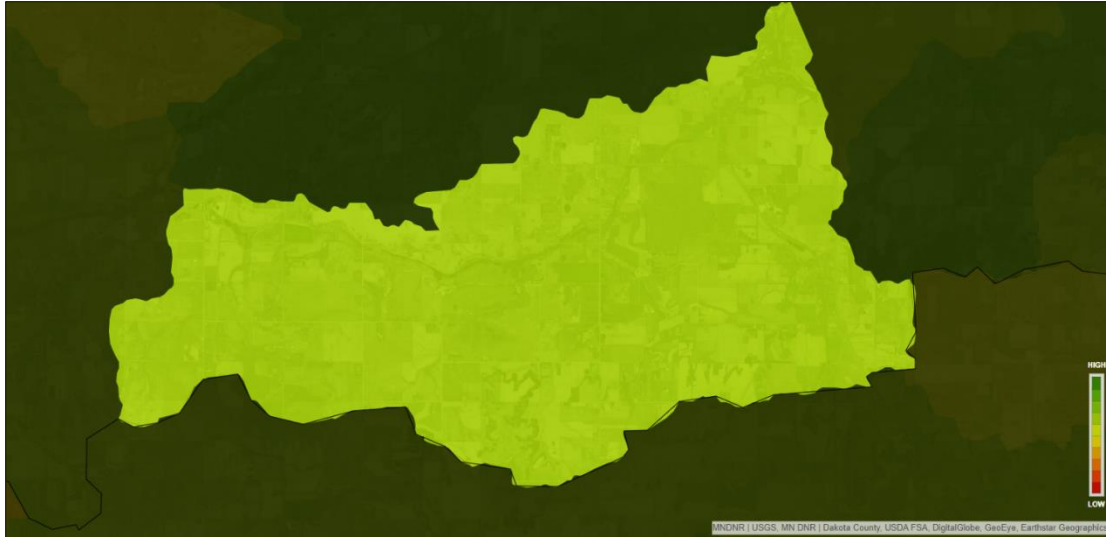
Altering land use and vegetation composition towards more agriculture can lead to increases in sediment. In addition to land use change, looking at surface erosion susceptibility can further the understanding of potential for sediment input. Utilizing the Watershed Health Assessment Framework (WHAF 2020), Figure 3 shows the soil erosion susceptibility of the watershed. This index takes into account the soil type K-factor and the slope of the landscape, but does not take into account land use. According to this index, erosion potential is predicted to be relatively low. It is important to understand that this is not the current level of erosion, but an indication of how inherently vulnerable the landscape is to erosion (WHAF 2020).

Figure 3. WHAF soil erosion susceptibility index.

Although soil erosion susceptibility is low, there are areas of possible surface erosion that can be improved. Rill erosion, caused by concentrated water running through fields, is the most common form of surface erosion in the watershed. The erosion directly enters a drainage system, where the sediment could then be transported downstream. An aerial photo review identified signatures of surface erosion at locations within the watershed (Figure 19).

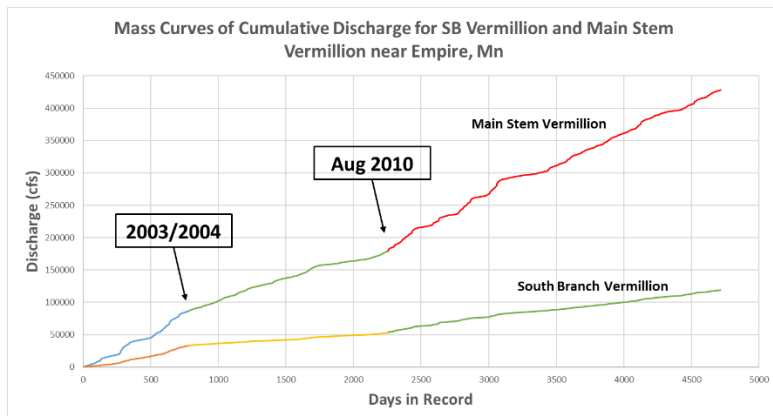
Comparing single mass curves of cumulative annual discharge for the South Branch Vermillion River gage and the USGS gage records identified similar break points between the 2003 and 2004 records as well as around mid-August 2010 (Figure 5). These break points have not been assessed for statistical significance, but have been identified to show the similar responses between the two adjacent watersheds to bring validity to assessing long-term trends on the main stem and relating those to the South Branch Vermillion watershed. These break points may reflect changes in hydrology, data collection/management, or other factors. A similar mass curve was also constructed using data from a baseflow separation analysis on the South Branch Vermillion data set using the University of Purdue's Web-based Hydrograph Analysis Tool (WHAT) (Kim et. al 2005). The baseflow curve showed the same break points as the other mass curves and was not included in Figure 5. These gage comparisons demonstrate the similarities between the adjacent watersheds and supports the case that there is utility in using the longer term USGS gage data set to help understand changing hydrology in the South Branch Vermillion.

Figure 5. Mass curves of daily South Branch and Main Branch Vermillion River.

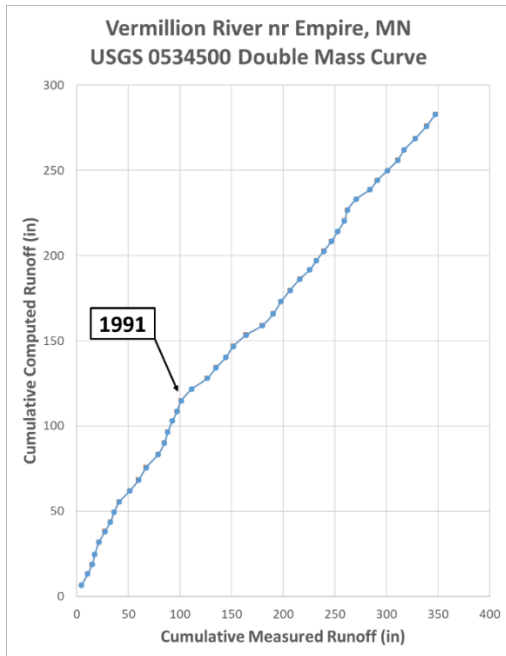
A double-mass curve analysis was completed looking at the relationship of precipitation and runoff on the USGS site's 45-year annual average stream flow record and annual gridded watershed averaged precipitation. The curve identified a significant break point at the year 1991 showing an increase in the volume of runoff per volume of precipitation when comparing conditions before and after the break point (Figure 6). Based on the single mass curves from Figure 5, there is an assumption that a break point of nonstationarity also occurred in the South Branch Vermillion Watershed.

Figure 6. Double Mass Curve.

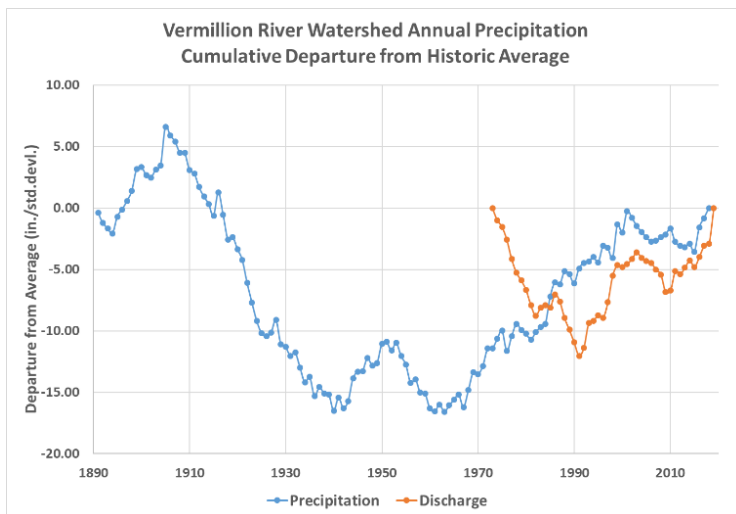
record over the same period indicating that annual peak discharge did not experience the same break in nonstationarity as the entire flow record. Additionally, both runoff and precipitation records in a cumulative departure from average graph identified the shift in 1991 runoff but not in the precipitation record (Figure 7).

Figure 7. Cumulative departure from average.

A shift in the hydrologic relationship between precipitation and runoff in the Vermillion watershed created two unique time periods, before and after 1991. This shift is not the result of changes in annual precipitation volumes, though timing of precipitation may have been a factor. Though there appears to have been a shift towards more runoff in the watershed per unit of precipitation, which likely holds true for the South Branch Vermillion watershed as well. Lack of long-term continuous discharge data collection in the South Branch limits the certainty of this conclusion, but when comparing recent data in the watershed with the USGS long term gage the two watersheds appear to be reacting similarly. With more runoff occurring in these watersheds it is possible sediment capacity has also increased. Stream channels, which are not connected to an active floodplain (incised) and/or have changes to their boundary condition (lack of deep rooted perennial riparian vegetation), tend to have stream instability issues including an increase in bank erosion.

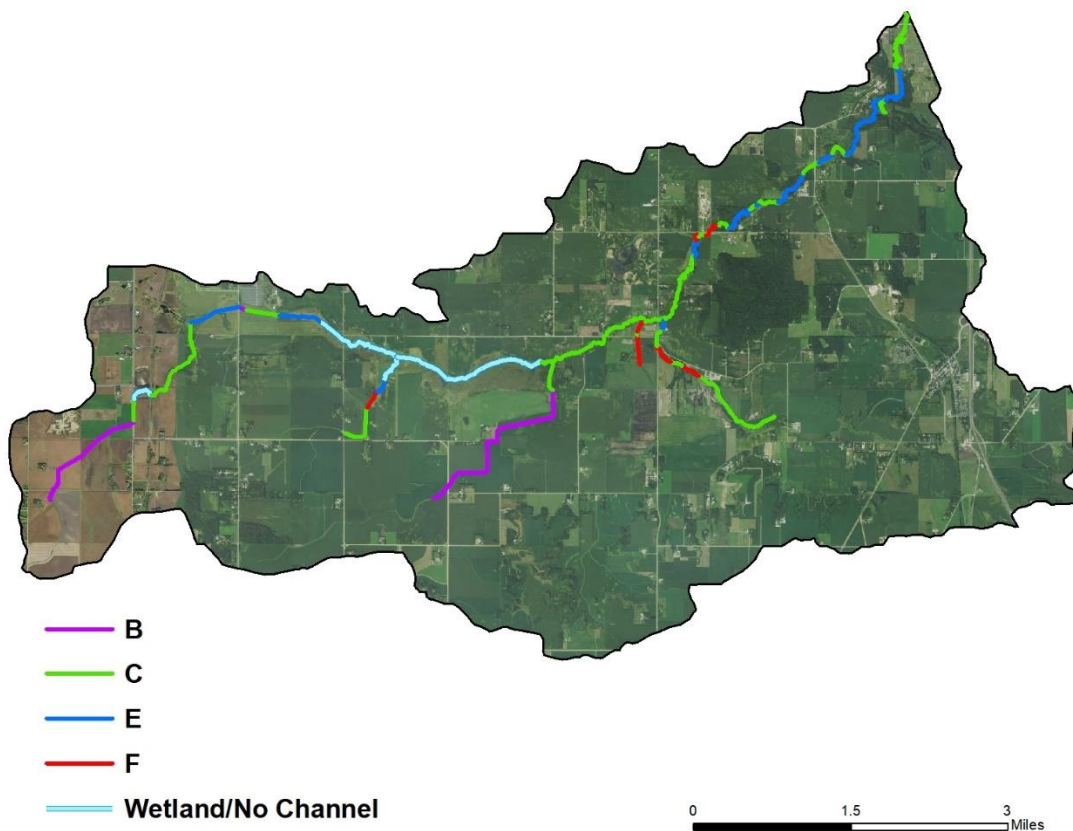
The geomorphic surveys are chosen using combinations of stream and valley types to represent the watershed. The information collected from these surveys can be extrapolated to like stream and valley types with similar boundary and stability conditions that were not sampled. This approach allows characterization of the watershed without having to conduct intensive surveys throughout. In the South Branch Vermillion watershed, the valley landscape is unconfined glacial outwash and till plains. The stream types most often stable in this valley landscape are B, C, and E. Light Detection and Ranging (LiDAR) derived digital elevation modeling was used to estimate channel and valley dimensions to quickly classify large lengths of stream and valleys with verification by aerial photos and field visits. This desktop method indicated large segments of potentially stable C and E stream types (Figure 9). A few reaches of unstable F stream type were also identified but were limited to crossing impacts and tributaries.

Figure 9. Stream type classifications of South Branch Vermillion.

Typically, ditches are not stable due to the lack of sinuosity and floodplain connectivity, though if left alone can slowly stabilize on their own. This can be a long process (years to decades) due to the lack of slope and sediment supply. Soils also play a significant role in determining how unstable a channel can be when ditched. Cohesive soils such as clays can hold the steep bank of a ditch better than sand and silt materials. In the South Branch Vermillion many of the ditched segments were well vegetated and have created enough of a small floodplain (gradually sloped sides) to have less

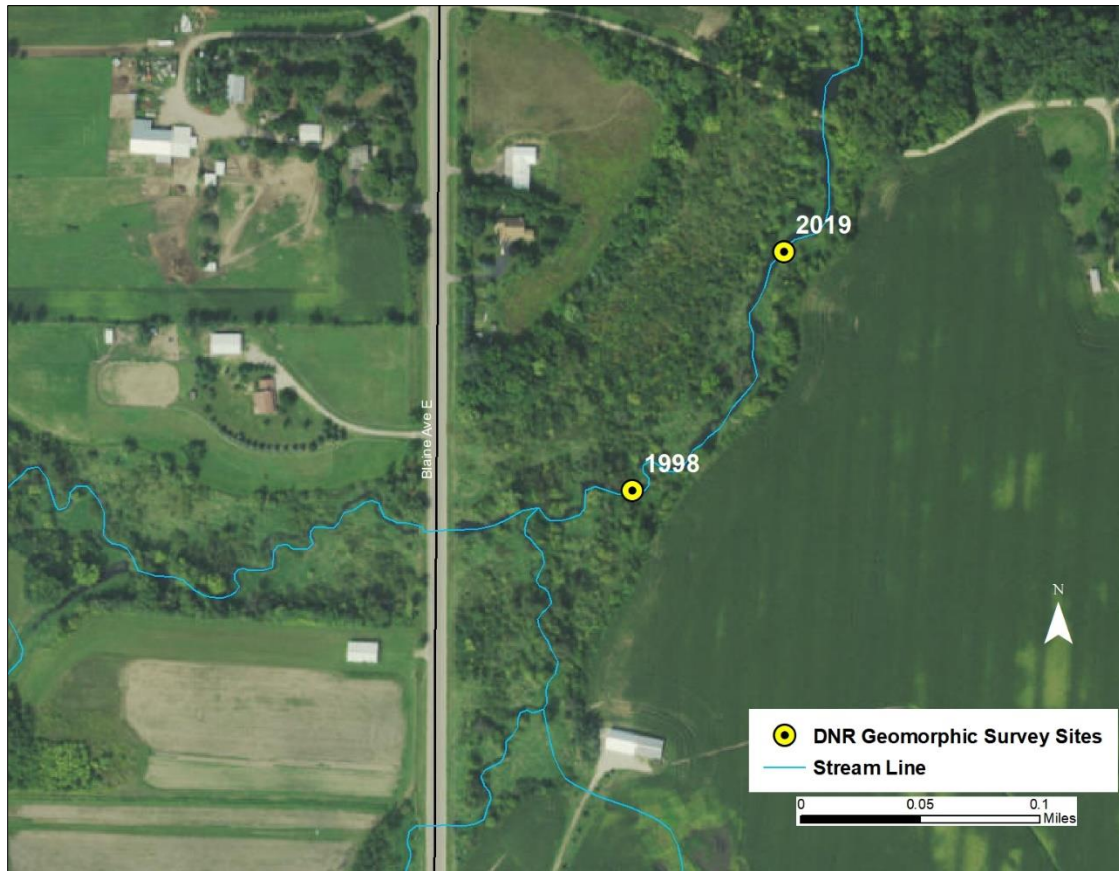
Desktop analysis and dashboard investigations identified the wetland complex near Audrey Avenue through the South Branch Vermillion Aquatic Management Area as the segment to focus field surveys on. However an active restoration, roughly one mile in length, through the management area was under construction and access was limited. The upstream survey (19-01) was chosen instead to take advantage of a historic DNR Fisheries geomorphic survey conducted in 1998, providing the opportunity to document change over time (Figure 10).

The current channel is classified as a C5 stream type with sand and silt substrate (Table 1). The width to depth ratio is very close to E type dimensions, meaning the sediment transport efficiency is greater than the average C stream type, because of the greater depth. The reach has a water surface slope of 0.00135 and a sinuosity of 1.3. Taking into account the condition of the upper banks, lower banks, and channel bottom the Pfankuch stability rating for the reach was rated as fair. Access to a wide floodplain and very low bank erosion positively influenced the score.

Figure 10. Locations of DNR geomorphic surveys and year completed.

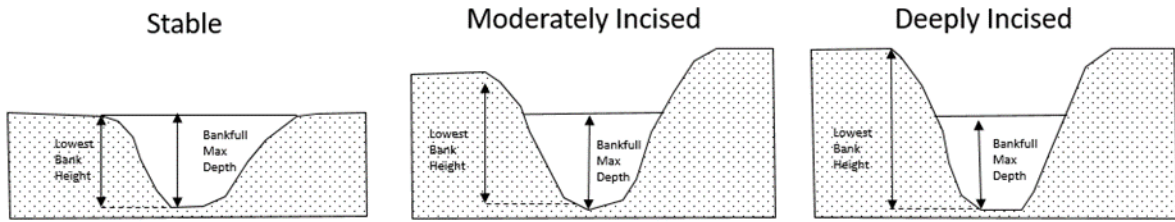
Lowering of the channel elevation, also known as incision, is a strong indicator of channel instability and accelerated rates of bank erosion. Incision is measured by bank height ratio (BHR), where the lowest bank height is divided by the maximum depth at bankfull (Figure 11). The average bank height ratio of the survey is 1.1, considered not incised. A measured entrenchment ratio of 16.41 shows that at flood flow levels the stream has access to a wide floodplain (Figure 12).

Figure 11. Bank-height ratio measurement and incision rating examples.

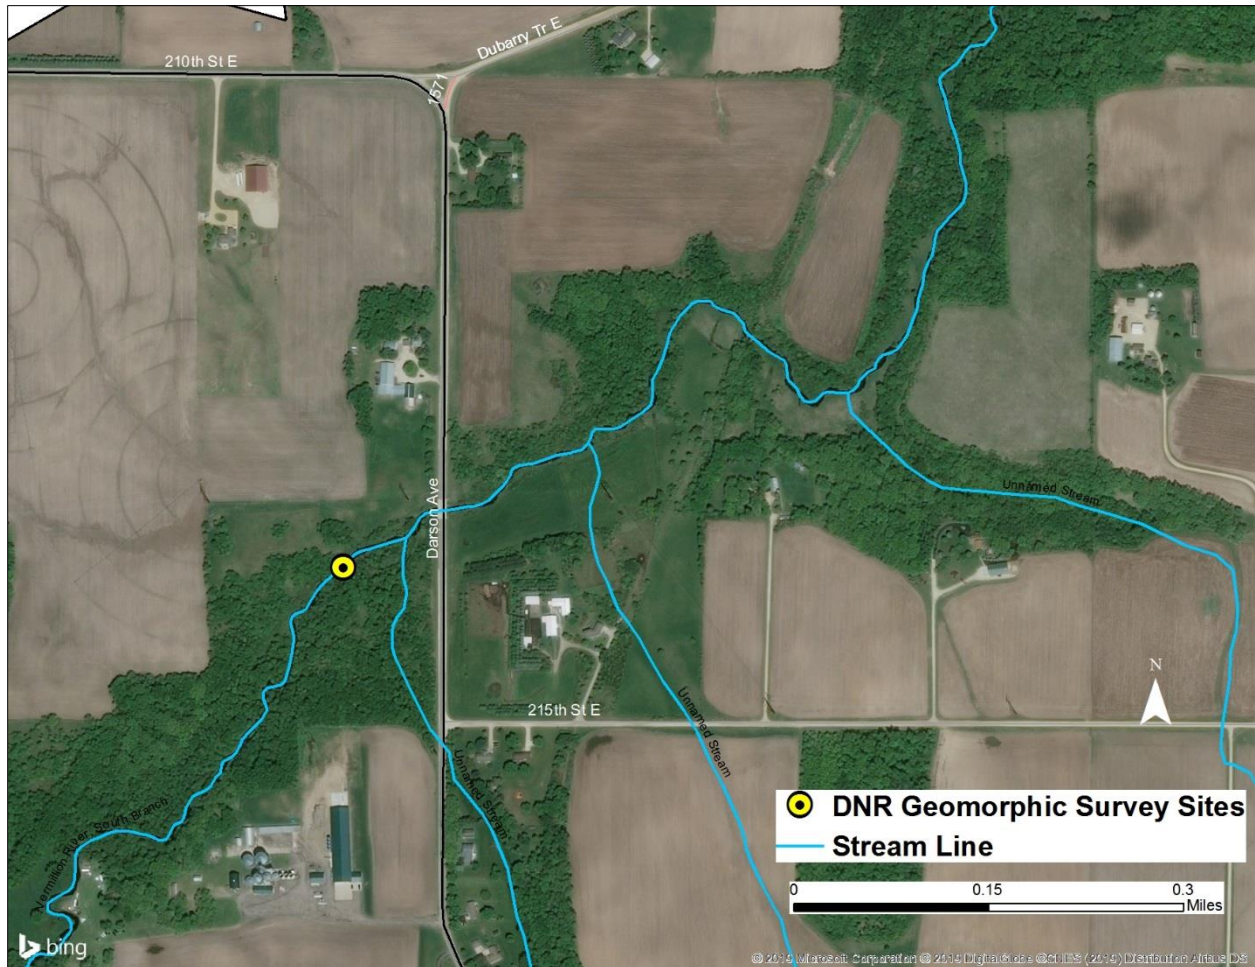
The second geomorphic survey was conducted upstream of Darson Avenue/County 81 (Figure 15). The channel is classified as a C5 with predominately sand and silt substrate (Table 3). Again, the width/depth ratio is close to an E stream type, meaning the channel is deeper than an average C channel.

Figure 15. Location of DNR geomorphic survey 19-02.
